NASA CR-121157
AI-73-31

FINAL REPORT
S8DR SHIELD EXAMINATION

ATOMICS INTERNATIONAL DIVISION
ROCKWELL INTERNATIONAL CORPORATION

NASA Lewis Research Center
Contract NAS 3-15705
L. Kaszubinski, Project Manager

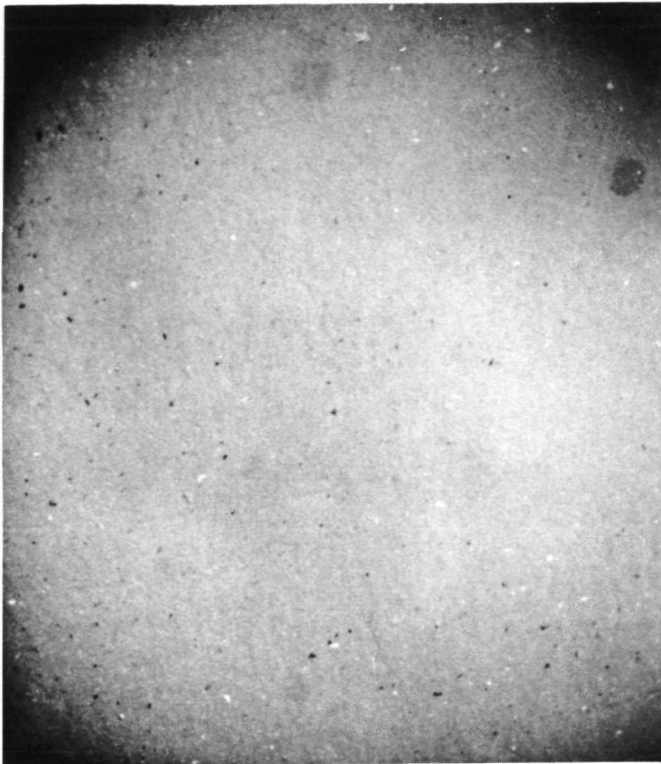
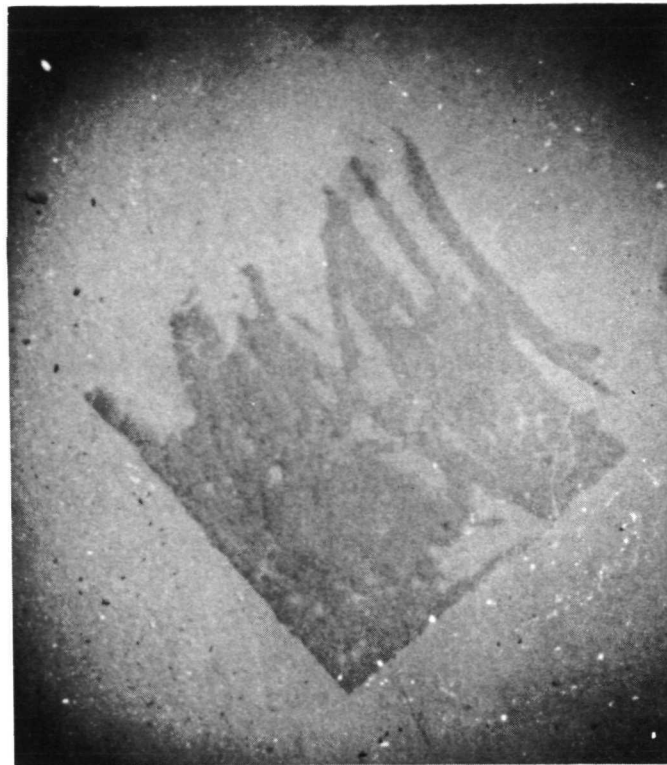
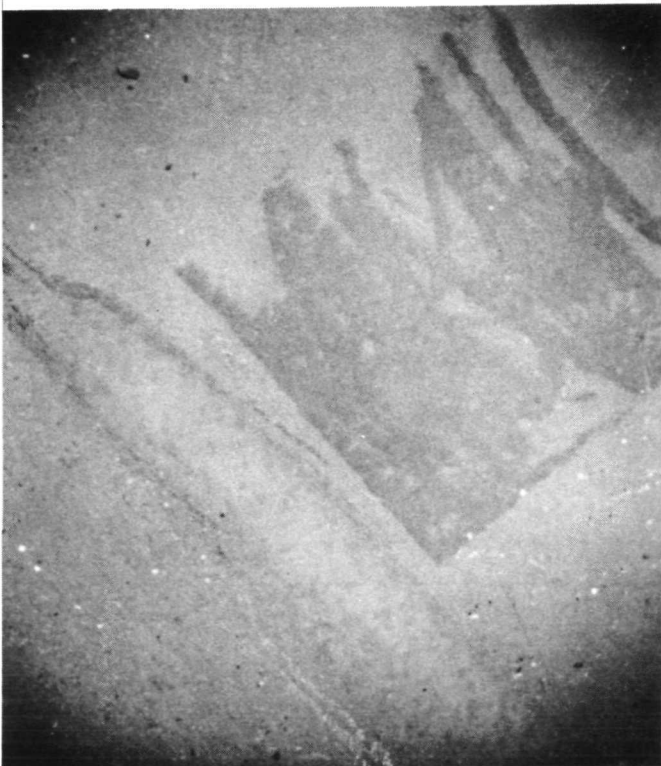
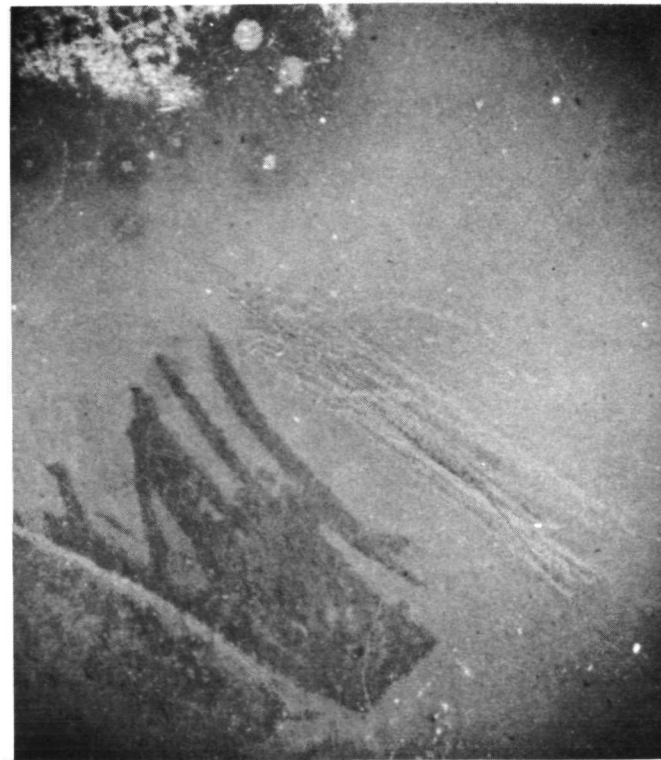
Figure 3A - DR110. Area near top of shield before application of Tucktape.

Figure 3B - DR111. Area near top of shield after application of Tucktape. No oxide adhered to the tape, only surface dust.

Figure 3C - DR112. Area near top of shield after 12 rubbing strokes with 180 grit paper.

Figure 3D - DR114. Area near top of shield after the scribing attempt. The chromic oxide material remained on the shield.

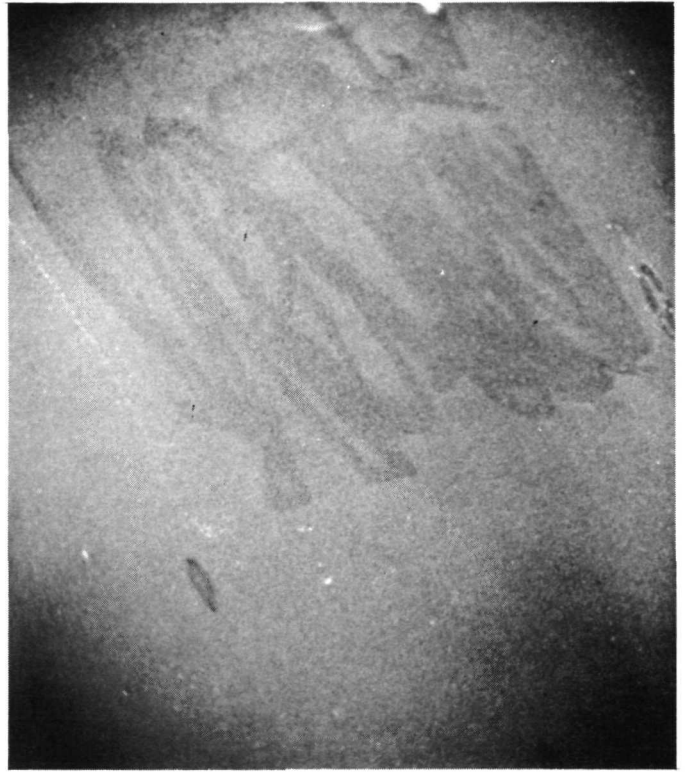
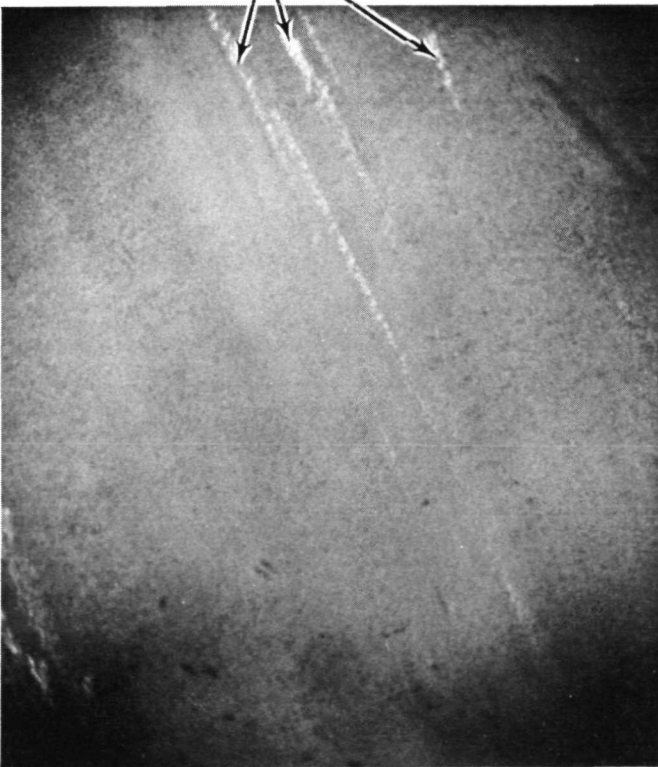
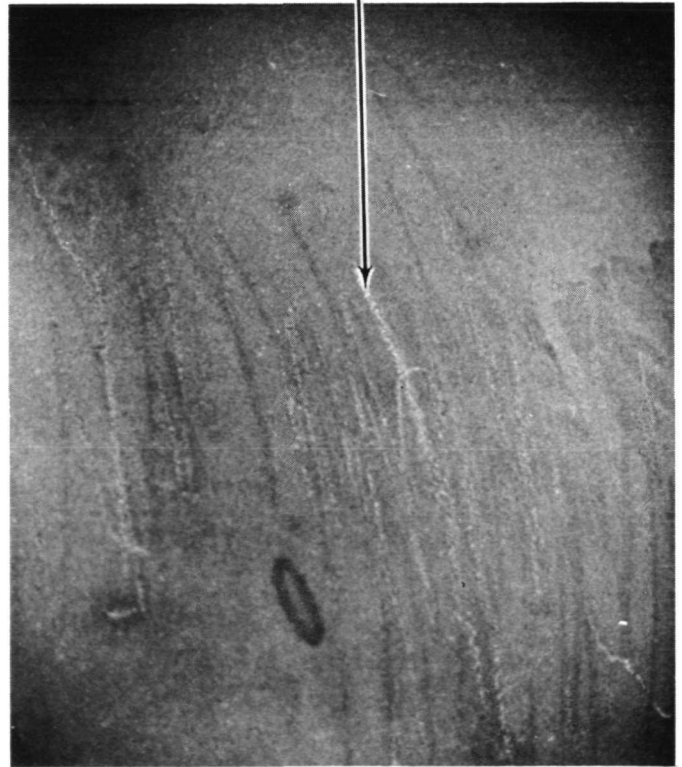
Figure 4A - DR115. Area 6" from bottom of shield before application of Tucktape.

Figure 4B - DR116. Area 6" from bottom of shield after application of Tucktape. No oxide adhered to the tape, only surface dust.

Figure 4C - DR117. Area 6" from bottom of shield after 72 rubbing strokes with 180 grit paper.

Figure 4D - DR118. Area 6" from bottom of shield after using the scribing tool.

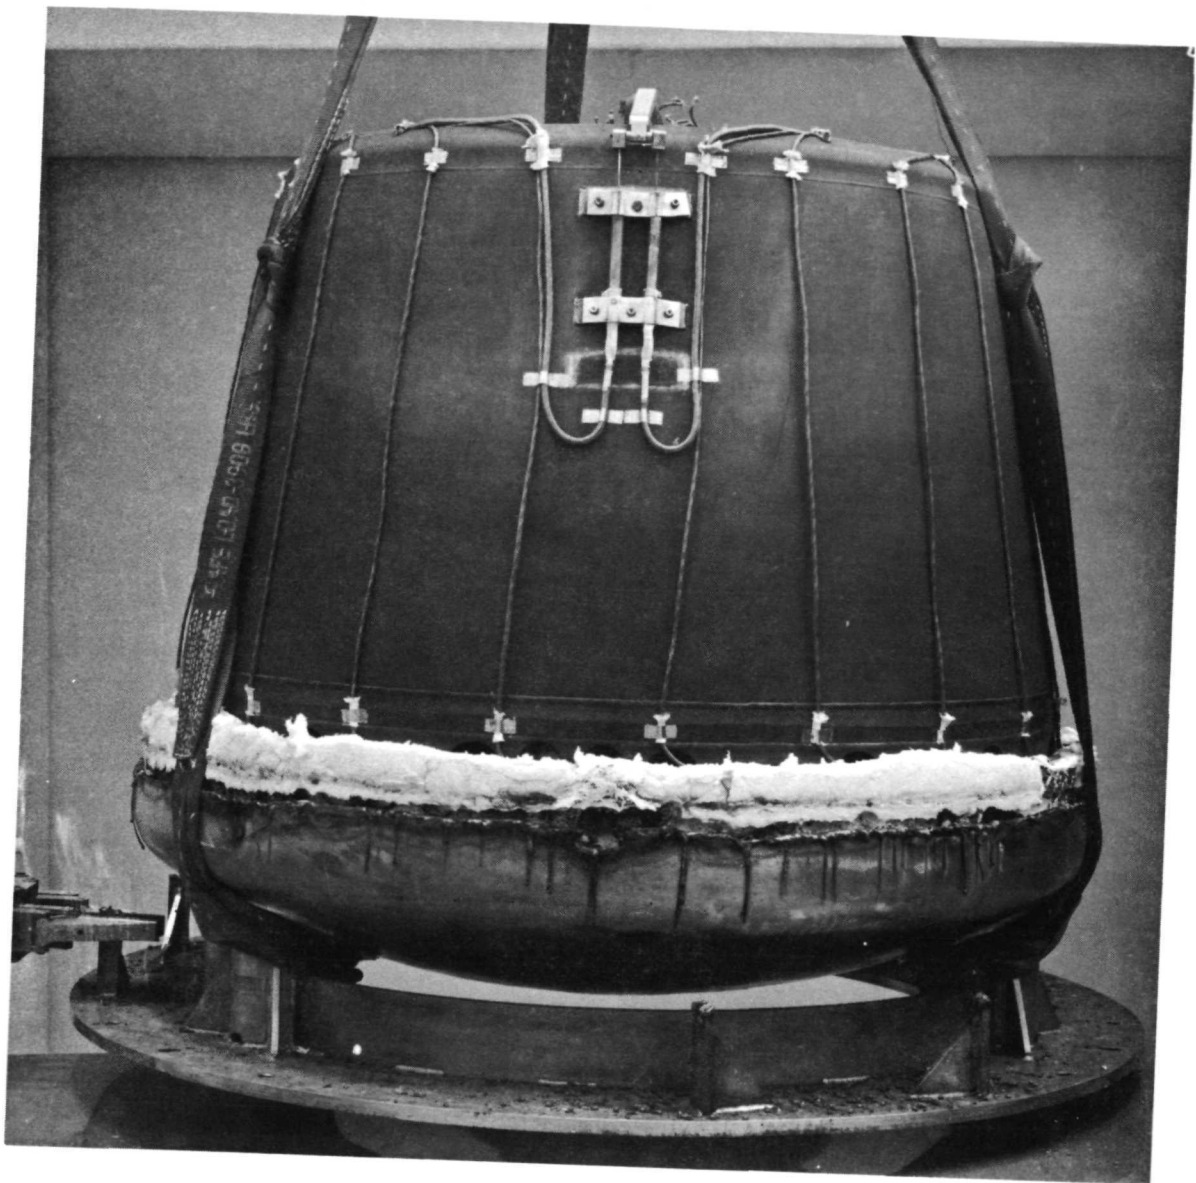
spalling emissivity were noted where the top head and side meet. Otherwise no surface anomalies were noted. A straight edge was placed across the top of the shield to determine if any bulging was present. A bulge of 5/8 inch was estimated as shown in Figure 6. A straight edge was also placed along the side wall near the crack. No bulge could be determined when compared to several other areas on the shield.

Figure 5, DR-121. Shield after confinement vessel removal, at 180°.

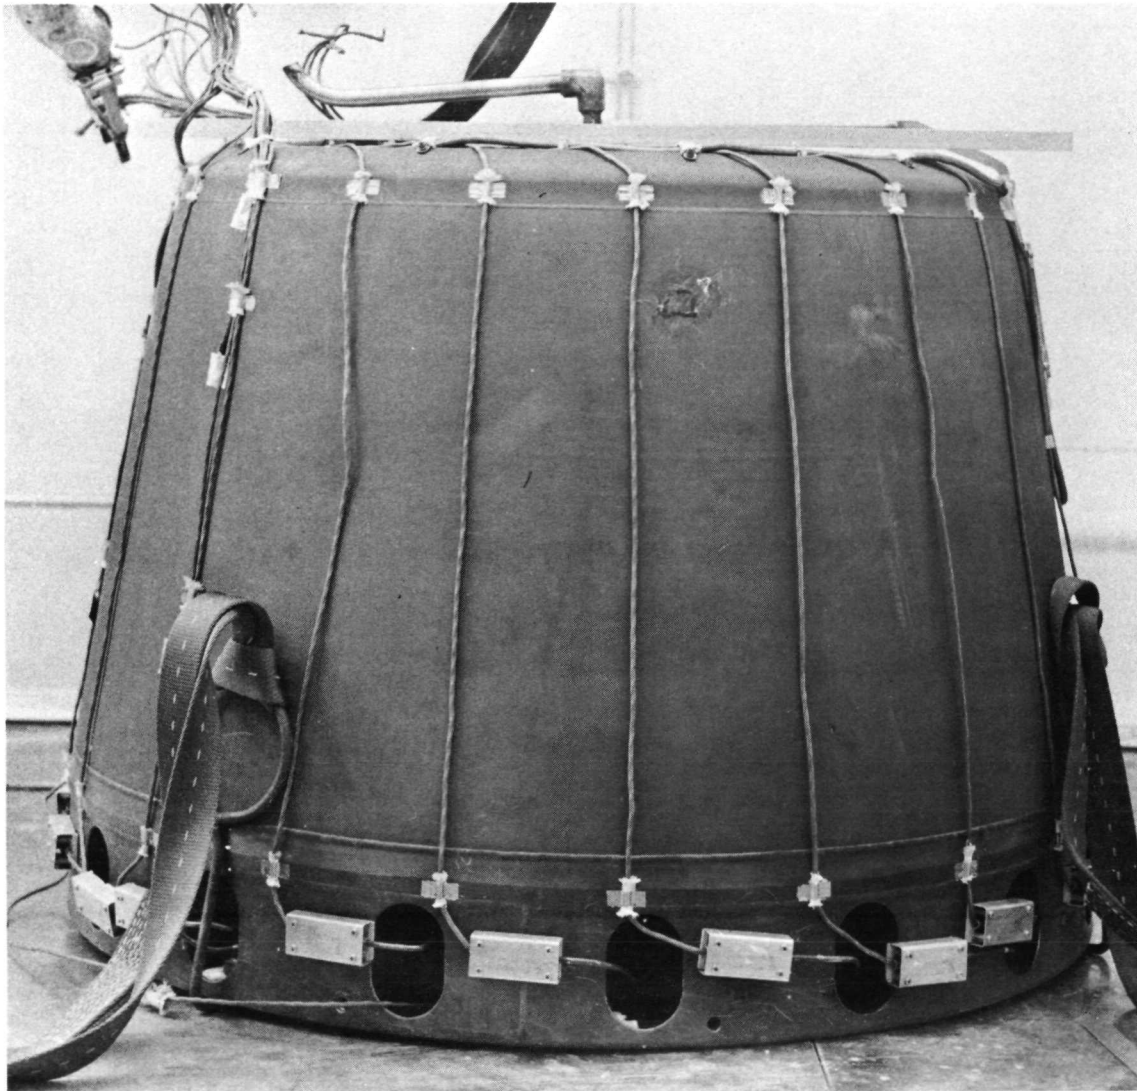
Figure 6, DR-128. Bulge determination using a straight edge across top of shield.

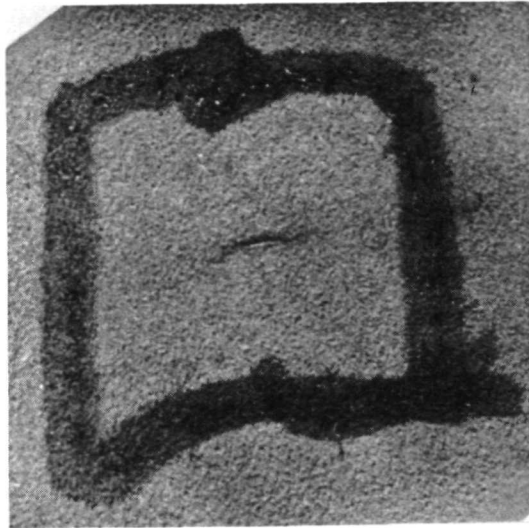
The shield was pressurized to approximately 25 psia helium using the 3/4 inch pipe. The shield was then examined for leaks using a helium sniffing probe. A small crack, ~ 1/4 inch long, 4 inches below the top weld, was located. Figure 7 shows the crack and crack location. The remainder of the shield was then leak tested.

Figure 7A, DR-126. Small crack in side wall of shield $\sim 1/4$ " long, 4" below top weld at 270° .

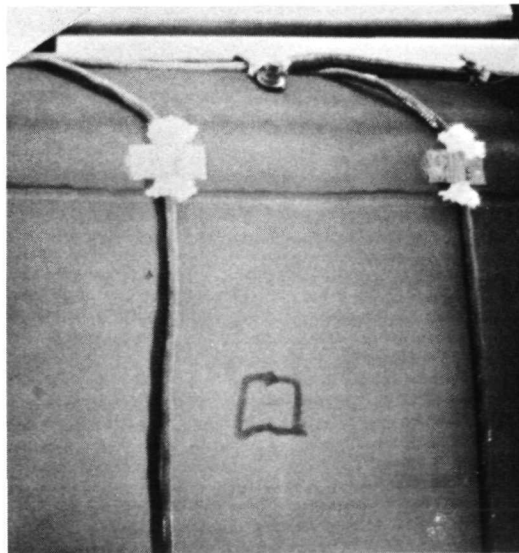
Figure 7B, DR-127. Low power Kollmorgen shot showing orientation of small crack.

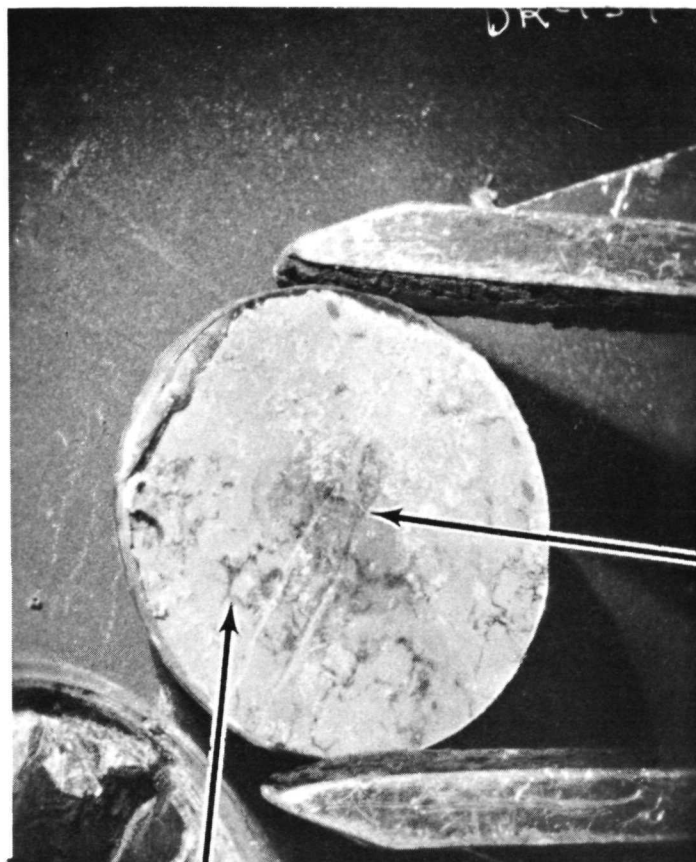
A two inch diameter wafer containing the crack was cut away under an argon purge from the shield side using a hole saw. The wafer (Figure 8) was readily removed. Visual examination of the back side

Figure 8, DR-134. Stainless Steel Wafer - Back side showing weld bead - main crack is centrally located (1.3X)

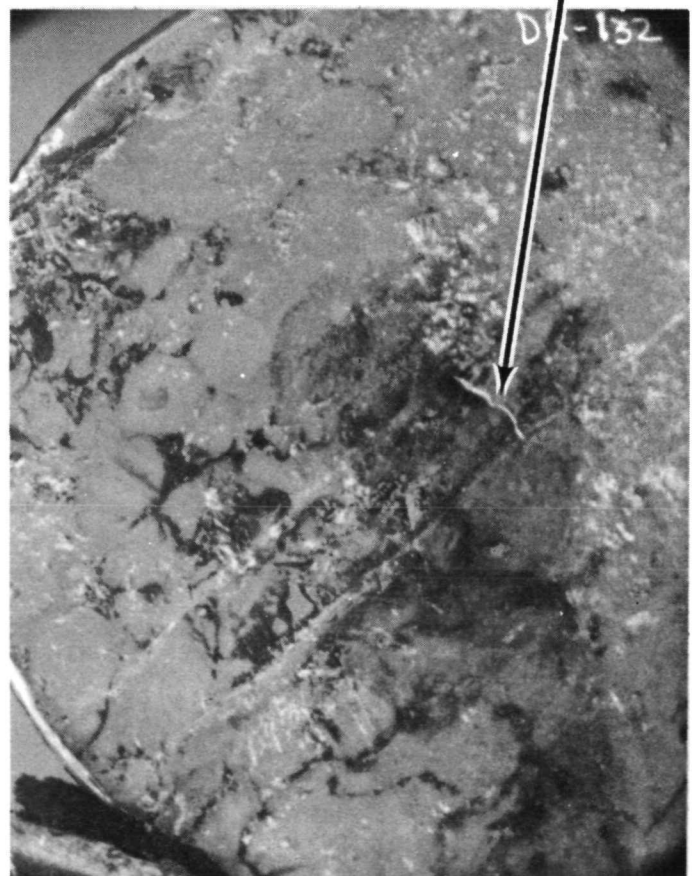
(side next to LiH) showed the crack clearly (Figure 9) and that it was on the weld seam as suspected. The LiH exposed when the wafer was removed had the characteristic appearance of irradiated LiH. Figure 10 shows the black, crystalline structure exposed after chipping out a sample. The sample was stored in a polyethylene bottle under an argon gas. The hole in the shield container was then sealed with epoxy and the argon purge terminated.

Figure 9, DR-132. Closeup (3.4X) of Main Crack in Weld Bead

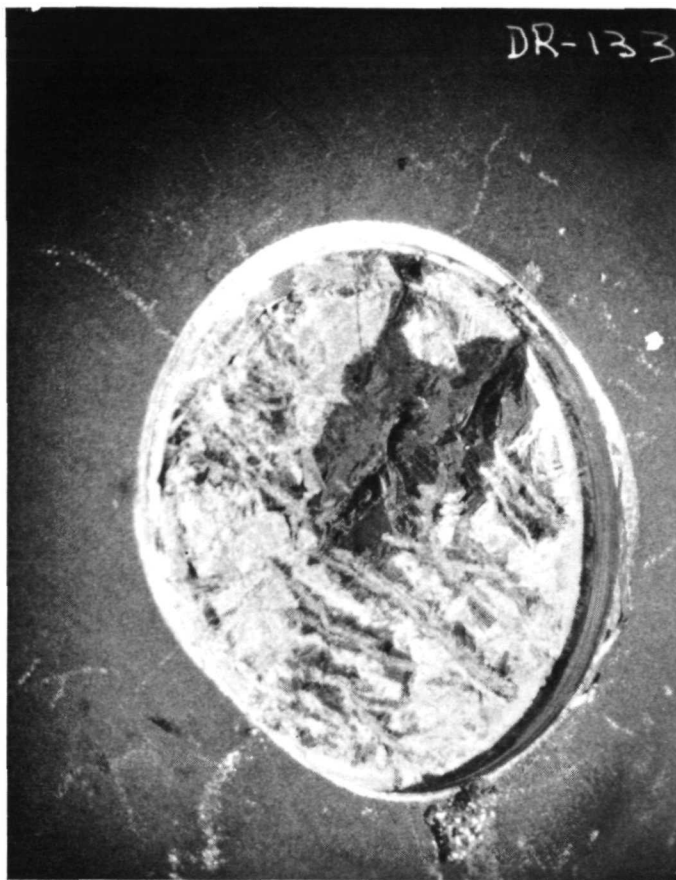
Figure 10, DR-133. Typical Crystalline Structure of Irradiated LiH (1.4X)

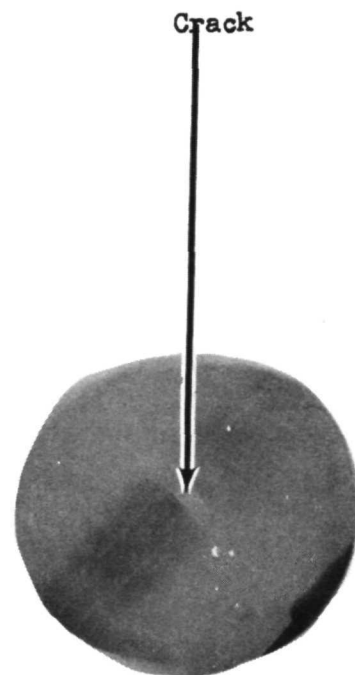
The wafer was removed from the cell and X-rayed perpendicular to the wafer and at a 45 degree angle (Figures 11 and 12 respectively). The X-rays clearly show the crack plane to be at a 45 degree angle to the plane of the base metal. No inclusions or other cracks are visible in the X-rays.

Figure 11, DR-151 X-ray. X-ray Showing Crack (taken perpendicular to face of wafer)

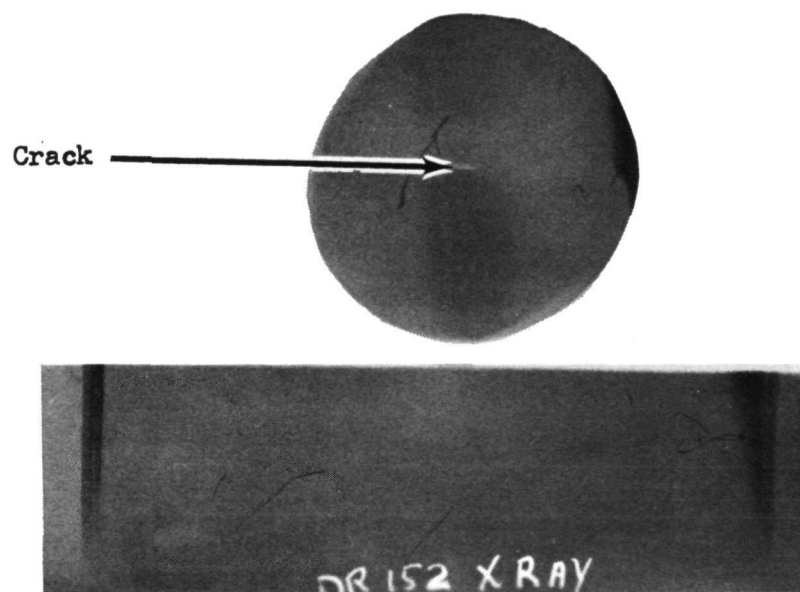
Figure 12, DR-152 X-ray. X-ray Taken 45 Degrees to Face of Wafer

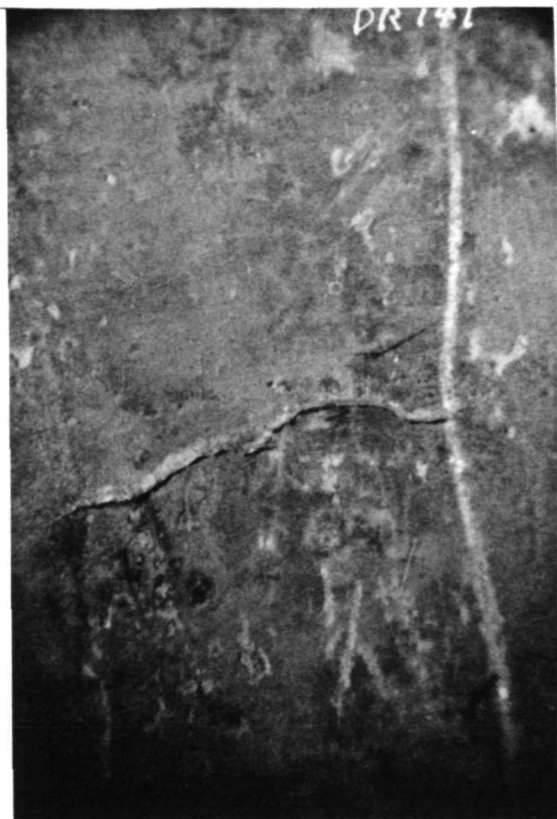
A stereomicroscopic (12.8x) examination of the wafer revealed additional surface "cracks" in the vicinity of the main crack (Figure 13). Figure 14 shows a hairline "crack" about 1/4 inch from the main crack. Figure 15 shows three small "cracks" located about 3/4 inch from the main crack. All the small "cracks" run essentially parallel to the main crack. The emissivity coating prevents identifying any crack from the outside except for the main crack which obviously penetrated. Figure 16 is a composite photograph taken at 4.3X across the wafer showing the complete weld bead. Figures 17 and 18 show the outside surface of the wafer. The entire weld bead was dye-penetrant inspected to determine if any other cracks existed. Only the main crack was identified indicating that the smaller "cracks" had very little depth. Subsequent metallographic examination removed all indications in polishing the surface confirming that the smaller "cracks" were just surface flaws a similar one of which could have been the initiation flaw for the main crack.

Figure 13, DR-141. Photograph of Main Crack - Inside Surface (12.8X)

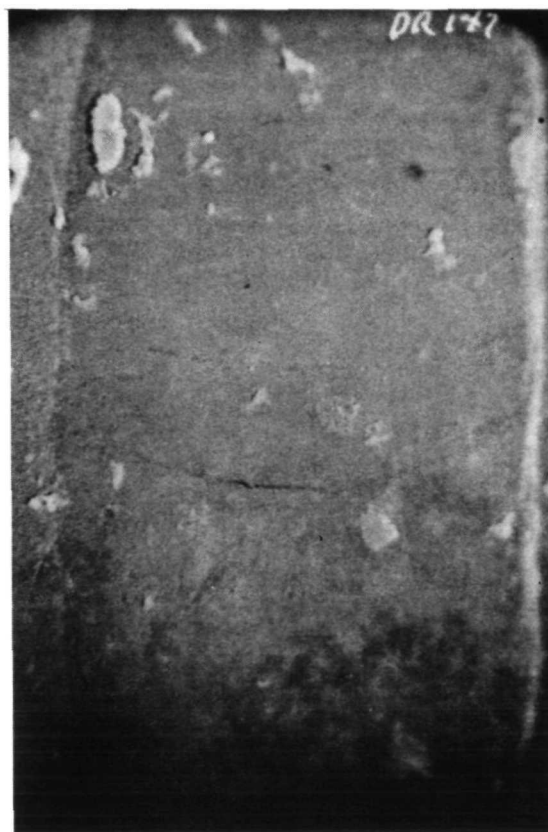
Figure 14, DR-147. Photograph of Hairline Crack Located ~ 1/2 inch From Main Crack (12.8X)

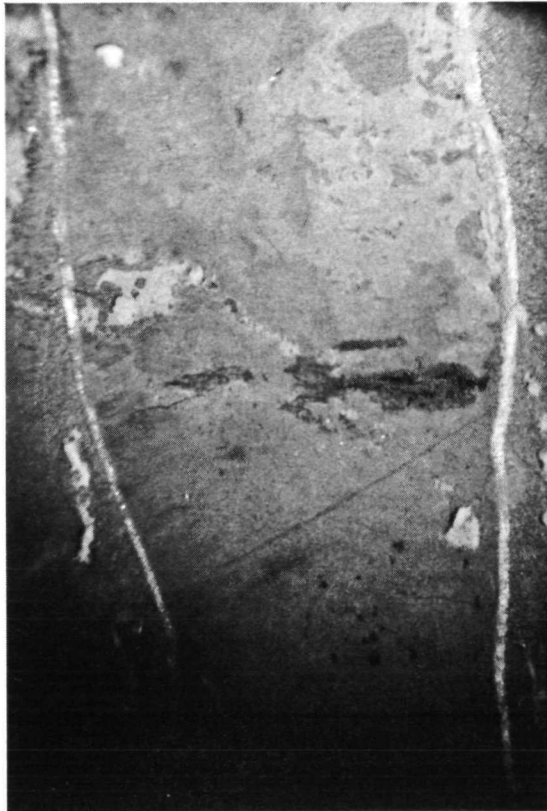
Figure 15, DR-142. Photograph of
Three Small Cracks Located $\sim 1/4$
Inch from Main Crack (12.8X)

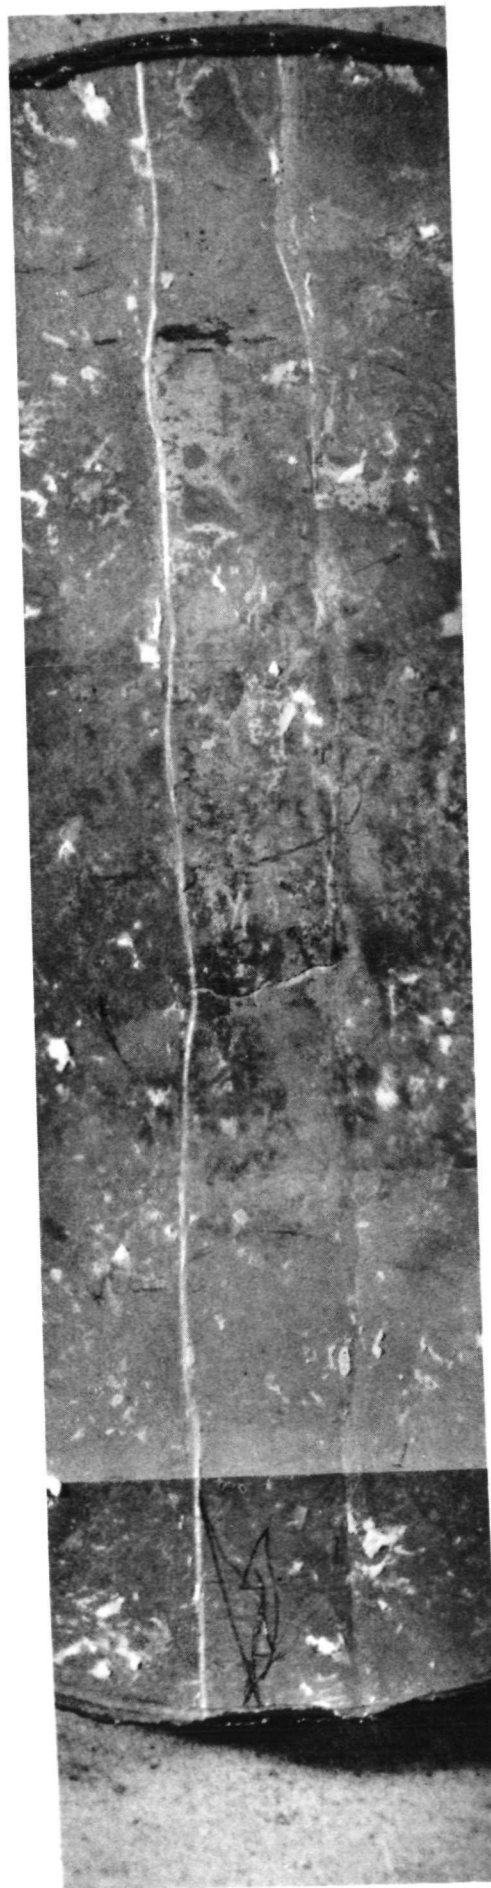
Figure 16. Stereo Photograph of Weld Showing Cracks (12.8X)

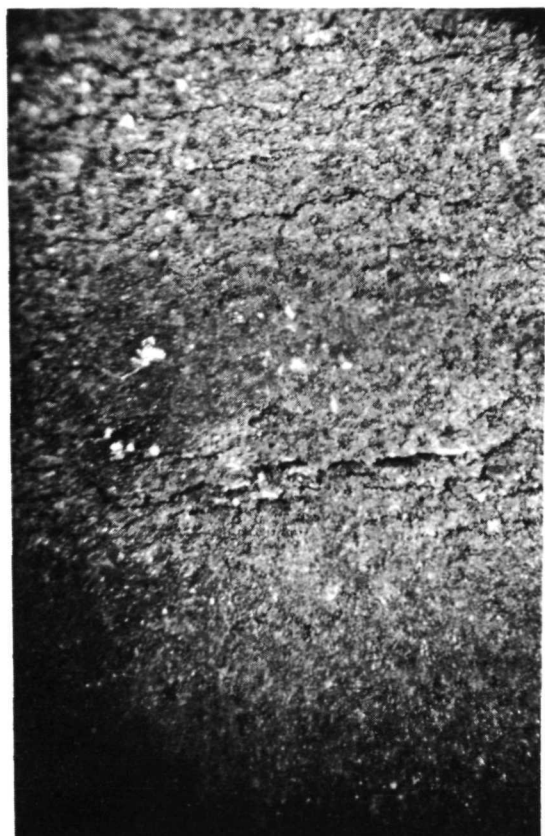
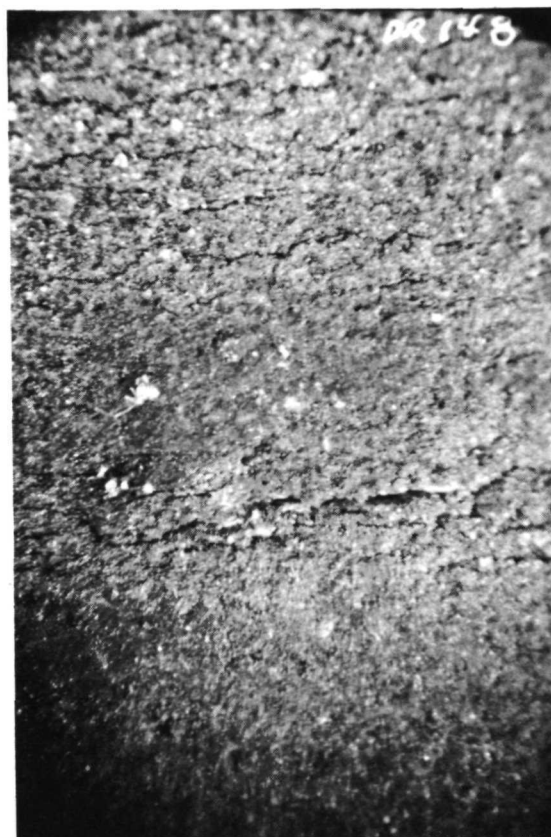
Figure 17, DR-148. Stereo Photograph of Outside Surface Showing Main Crack and Other Surface Cracks Not Related to Other Metal Cracks (12.8X)

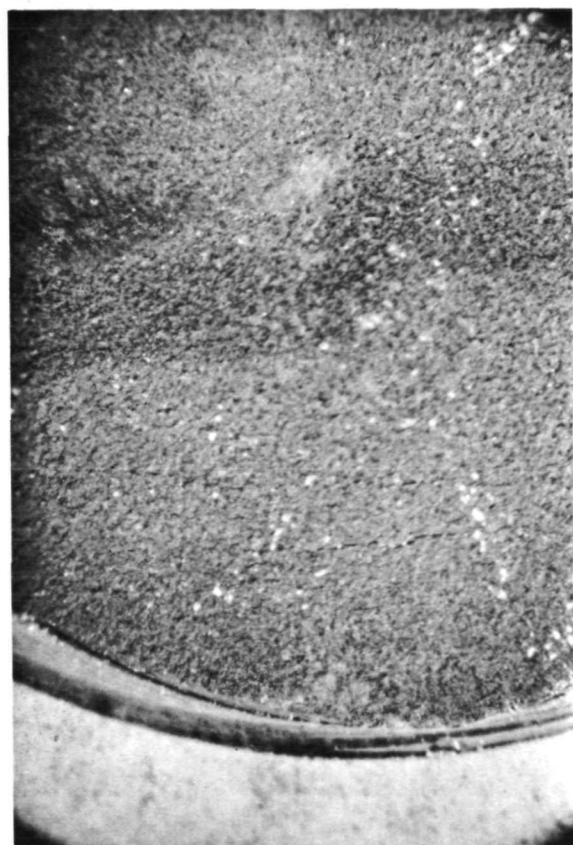
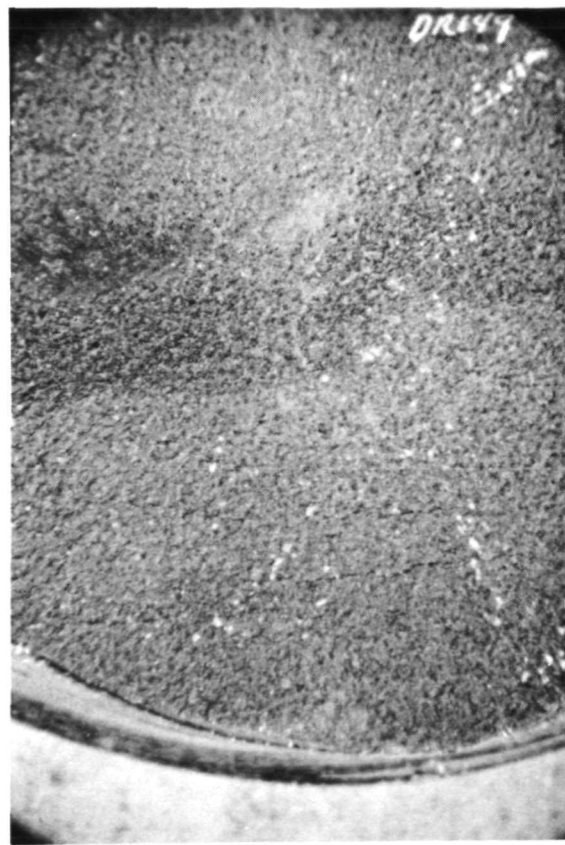
Figure 18, DR-149. Stereo Photograph of Outside Surface Showing Emissivity Coating Cracks Not Related to Metal Cracks (4.3X)

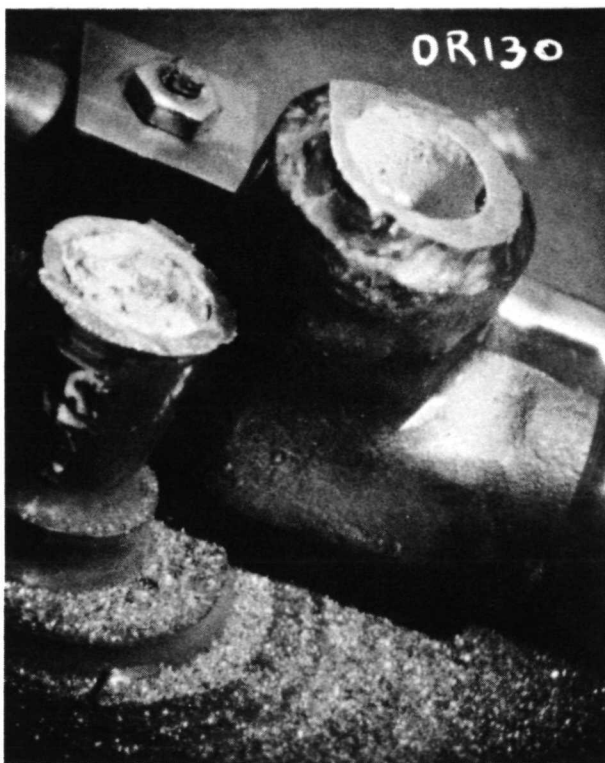
A purge of argon was started and the center pipe was cut out with the hole saw (Figures 20 and 21). The pipe appears to be filled with lithium hydroxide while the material in the shield can has the typical appearance of irradiated LiH, i. e., a black, crystalline appearance. A hole was also cut at half-radius (Figure 22). The LiH here also appears typical of irradiated LiH. Samples were taken from both locations and sealed under argon. The LiH at both locations appear to be tight against the stainless steel container. Both holes were sealed with epoxy after the LiH samples were taken.

Figure 19, DR-130. Pipe Elbow Showing Lithium Hydroxide in Pipe Nipple

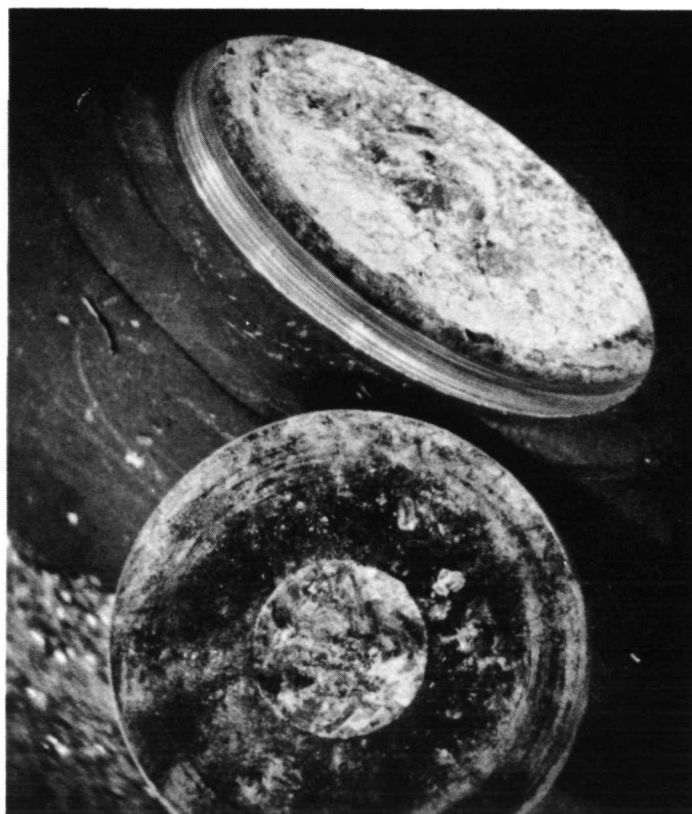
Figure 20, DR-140. View of Wafer Cut Out of Top Head Showing Inside Surface (1.4X)

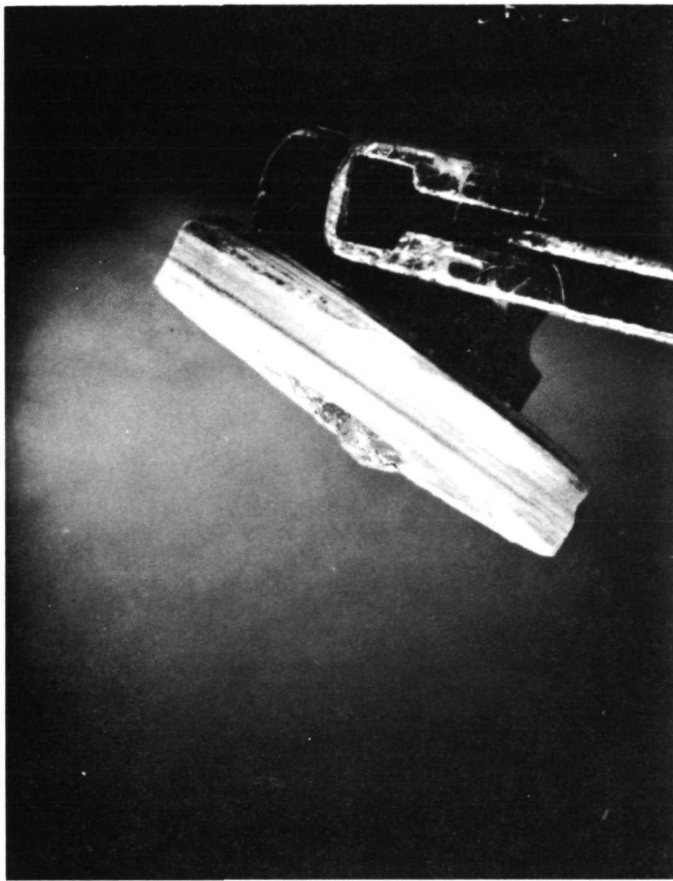
Figure 21, DR-139. View of
Wafer Cut From Center of Head
Showing LiH Crystalline
Structure at Shield End of
Pipe Nipple (1.4X)

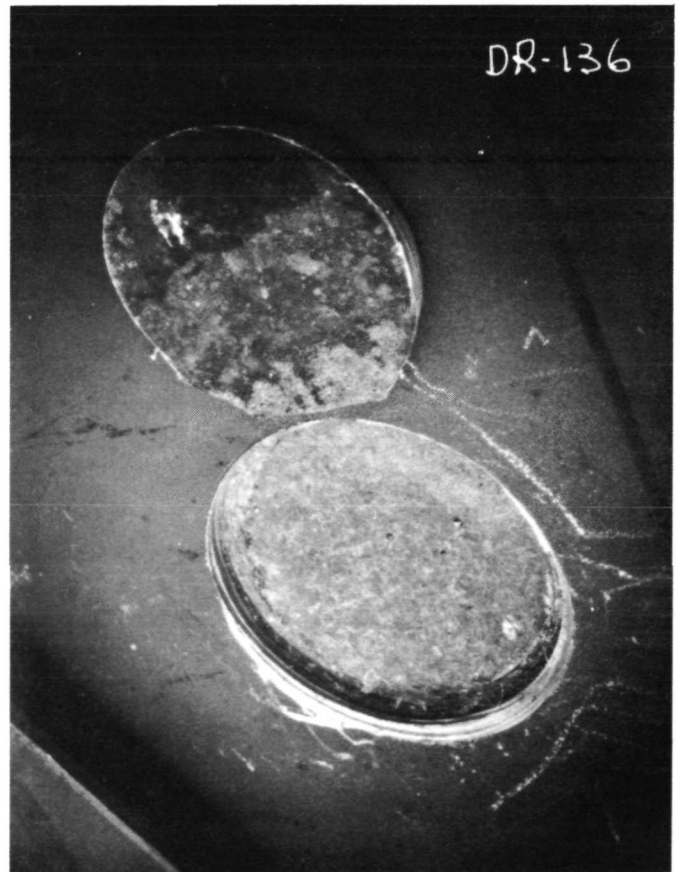
Figure 22, DR-136. View of
Wafer and Hole at Shield Head
Mid-radius

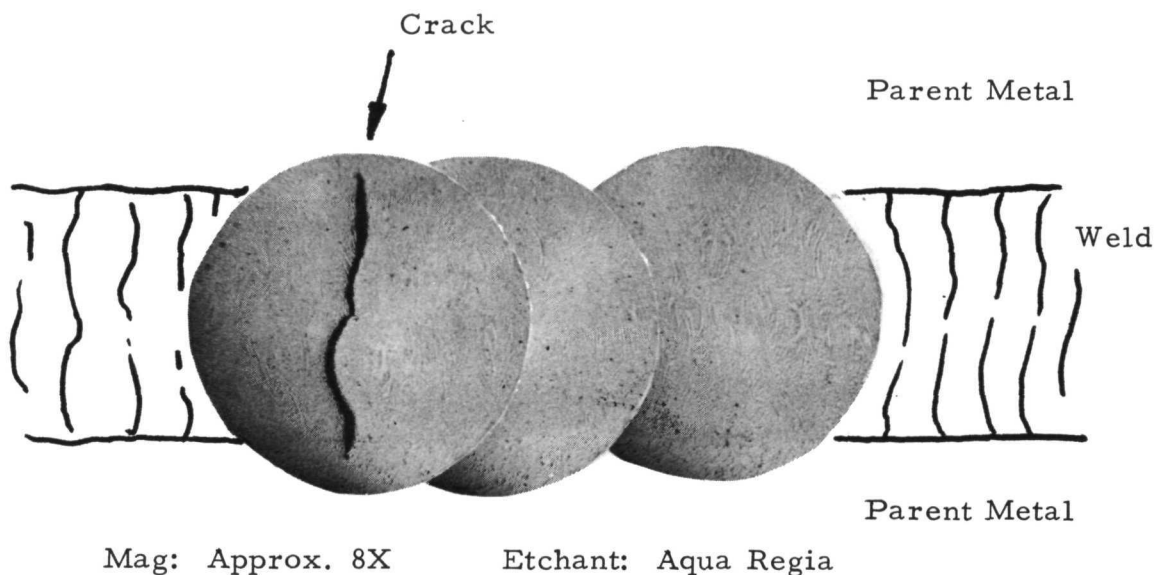
Figure 1. Macrophotographic Montage Showing
Relationship of Crack and Weld Zones

Based on the visual metallurgical examination of the weld the crack extended transverse to the weld fusion zone and slightly into the heat effected zone on both sides of the fusion zone, Figure 1, Appendix A. The crack extended through the weld. It was noted that the I. D. (root side) had not been made fully flush by the roll planishing operation as evidenced by 0.005 - 0.010 inch protrusion of residual droptrough (Figure 2, Appendix A). The section was mounted such that the face surface (Figure 2, Appendix A) was accessible for polishing. This surface was prepared metallographically for analysis of the microstructure.

A crack was visually observed in the longitudinal seal weld of the cone portion, P/N S8DS-13004-3, of a shield assembly, P/N S8DS-13003. The crack extended transversely across the weld fusion zone and slightly into the heat affected zones on both sides of the fusion zone (figure 1). The crack extended through the thickness of the weld.

View looking down at outer surface of weld (top surface removed by metallographic preparation). Note distortion of dendritic structure caused by roll planishing. Also note areas of recrystallized structure (lighter appearance) caused by roll planishing and subsequent exposure to elevated temperature.

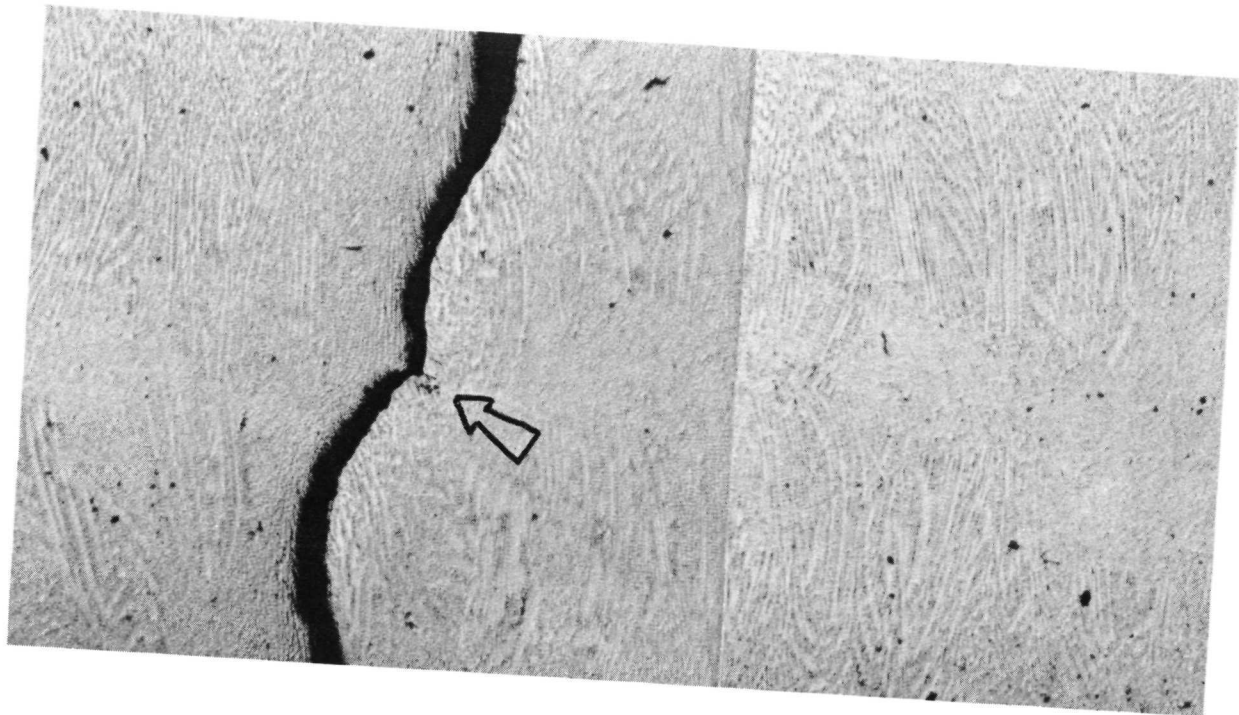
Figure 3
Enlargement of Same View Shown in Figure 1

Examination of the metallographic mount showed that the crack was intergranular and appeared to initiate at a small discontinuity at the approximate center of the weld (Figures 3 and 4, Appendix A). It was also noted that the dendritic structure was distorted, apparently a result of planishing, and did not follow a normal semi-circular or triangular freezing pattern (Figures 1 and 3, Appendix A). There were islands of what initially appeared as equiaxed grain structure observed in the fusion zone (Figures 1, 3, and 4, Appendix A). This was considered abnormal for the weld involved and was later interpreted as recrystallized cold-worked material (see discussion in Appendix A). The structure was essentially all-austenitic with virtually no delta ferrite visible (Figure 4, Appendix A). This conclusion was reached by comparing the viewed structures with weld structures known to contain specific delta ferrite contents. The dendritic formations (other than being distorted) were generally long, narrow, and almost perpendicular to the direction of rolling (Figures 1 and 3, Appendix A). There was no evidence of sigma phase.

Examination of the metallographic mount showed that the crack was intergranular and appeared to initiate at a small discontinuity at the approximate center of the weld (figures 3 and 4). It was also noted that the dendritic structure was distorted, apparently a result of planishing, and did not follow

Arrow denotes possible initiation point of crack at a clustered discontinuity. Distorted dendritic structure and recrystallized zones are obvious. Propagation appears to be intergranular.

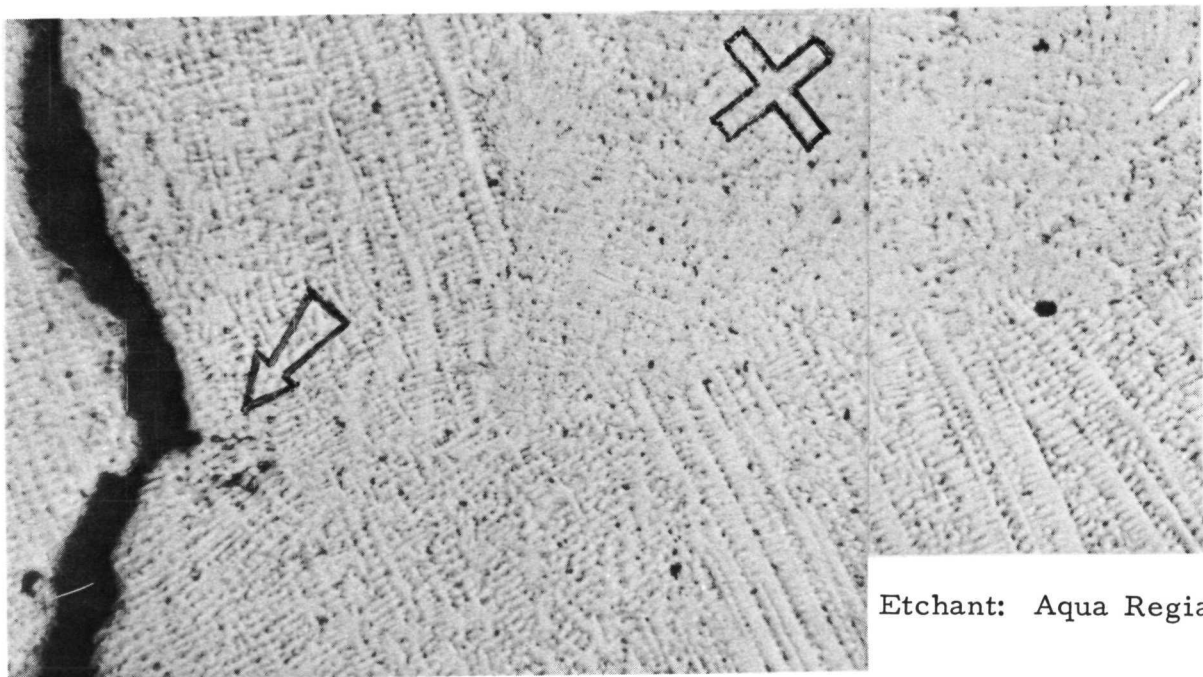
Enlargement of Point of Possible Crack
Initiation Denoted in Figure 2

1. A low ferrite level heat of material was autogenously GTA-welded at high speed, resulting in an internal micro-fissure.
2. A moderate amount of cold work was imparted to the weld by roll planishing (figure 4C).
3. The fissure was not propagated sufficiently, if at all, to be detected by liquid penetrant, helium mass spectragraphic and radiographic examinations.
4. The weld was subjected to thermal excursions which recrystallized the cold worked portions of the weld and probably propagated the fissure (crack) to just short of resulting in leakage.

Welding of type 347 (or type 316) stainless steel without adequate addition of weld filler metal of a composition which can yield at least 3% delta ferrite must be prohibited in applications where weld fissuring or cracking is intolerable. Exceptions can be made if the composition of the base metal meets the 3% ferrite level, or a suitable weldability test has been performed and the material judged to be weldable.

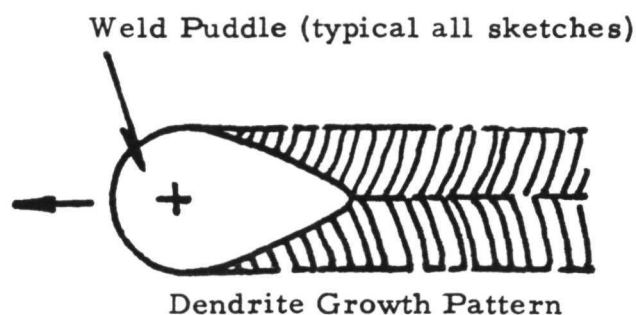
- b. The perpendicularity of the dendritic structure disclosed that a welding procedure had been used which was conducive to weld fissuring. Continuing research programs at Rensselaer Polytechnic Institute, Troy, N.Y. by Dr. Warren Savage, et al.^(5, 6, 7), have shown that weld puddle shape definitely controls the directionality of dendrite grain epitaxial growth. A triangular pattern, or tear drop puddle, results in the perpendicular direction observed in the shield weld (figure 5A). A semi-circular pattern, or elliptical puddle, results in a more variable curving direction (figure 5B). Solidification direction should not be confused with the mechanical ripple pattern which appears on an as-welded bead (figure 5). Ripple is caused by a complex interaction of solid/liquid interface progression and varying surface tension (amended by mechanical agitations in weld velocity or filler wire feed)⁽⁸⁾. Savage's work⁽⁹⁾ also concluded that a perpendicular pattern generated conditions more susceptible to center-bead cracking in alloys unforgiving of such conditions (such as 347). The tear-drop puddle forces final freezing of large amounts of segregate (in this case Fe, Cb) to occur at the weld center-line. The elliptical puddle distributes the segregate in smaller amounts over a longer path, thus reducing fissuring incidence. The teardrop shape is associated with high welding speed.

A. Triangular Pattern. The tear drop shape is associated with high speed, center-bead segregation, and center-bead cracking. This was typical of the weld examined in this investigation.
